FREE DRAINING SEAL (FDS) REPORT

TEST SECTION

In cooperation with Florida Department of Transportation - District 5

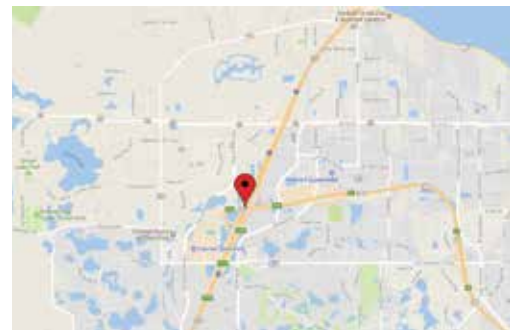
Figure 1

MSE Construction and Materials, LLC (MSA-CM) working in conjunction with FDOT District 5 Maintenance Department set up a Test Section for the use of the Free Draining Seal (FDS) as a retrofit for Mechanically Stabilized Earth (MSE) Structures that have vegetation growing out of the joints. The test section is located along the east side of I-4 near the intersection of I-4 and SR 417 (Fig. 1). The MSE Wall chosen is a wingwall for Bridge #770078 in Seminole County, Florida. The Test Section has joints with FDS and joints without the FDS product.

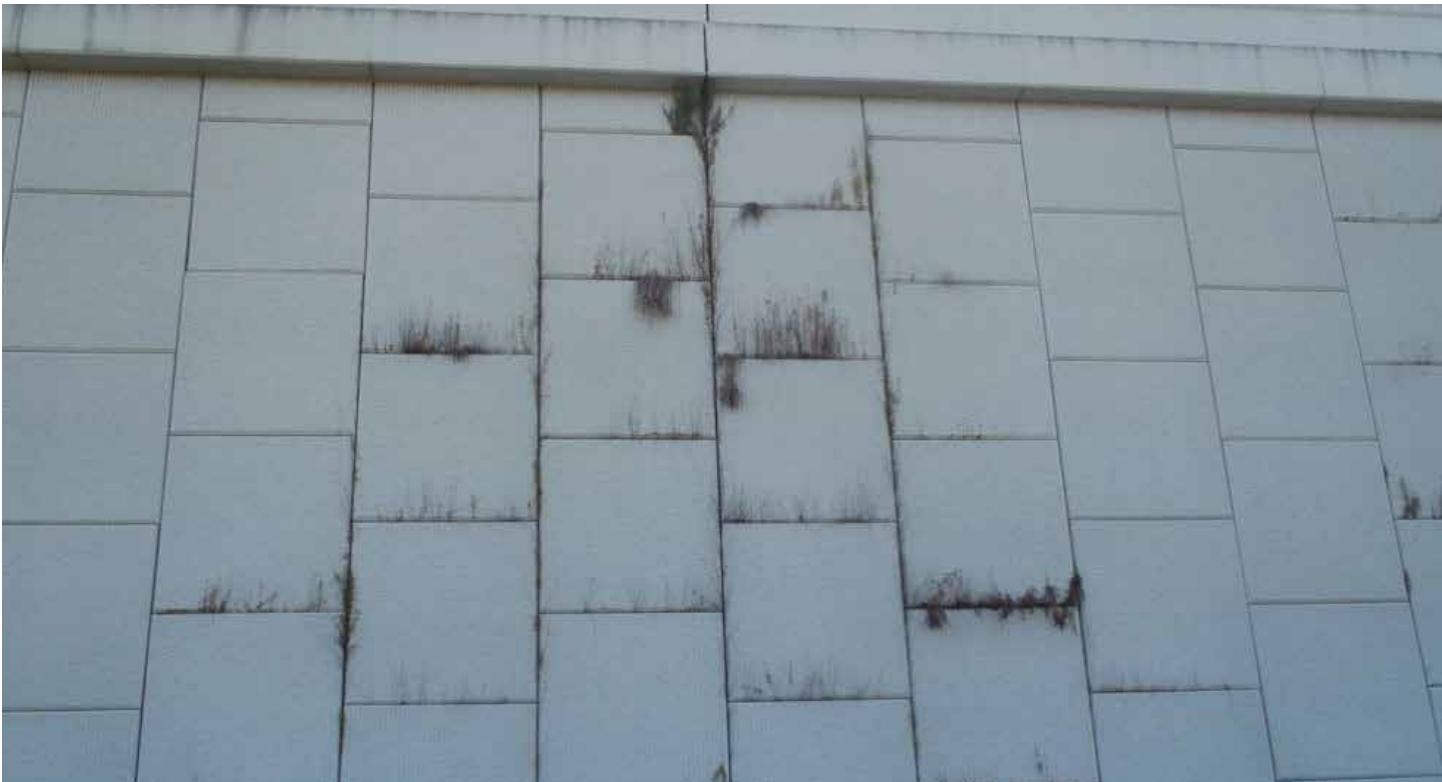
On January 14, 2013 the vegetation growing in the MSE Wall (Fig. 2) was removed from the joints in the test sections. The following are two important items that were noted when the vegetation was removed:

1. The plants were mostly ferns that had been growing in the joints for an extended period of time and the roots of the ferns were difficult to remove. It appeared that if the ferns were large, and had been growing in the joints for an extended period of time, that the roots had grown into the filter fabric and could not be completely removed.
2. There were plants that had a larger root system that had grown into the joints. If these plants were left to continue to grow, there would be a good chance the panel would spall at the joint where the plant was growing.

Figure 2: Test Section without FDS prior to vegetation removal.

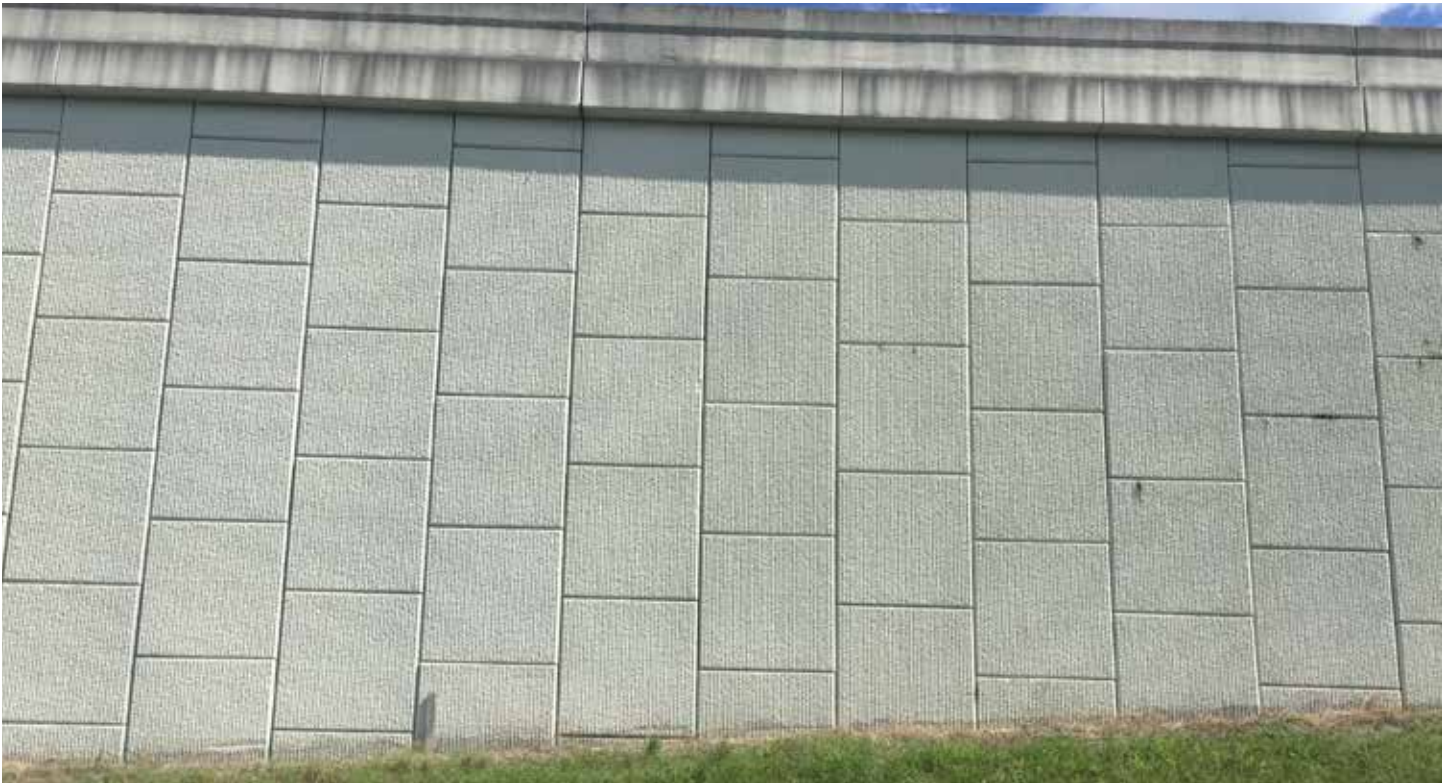
After the vegetation was removed, the FDS product was installed in four columns and 3 columns were left open without the FDS product. (Fig. 3). In addition, two joints that were leaking in the barrier on top of the MSE Wall were sealed with caulk.

Figure 3: Test Section after the FDS has been installed.

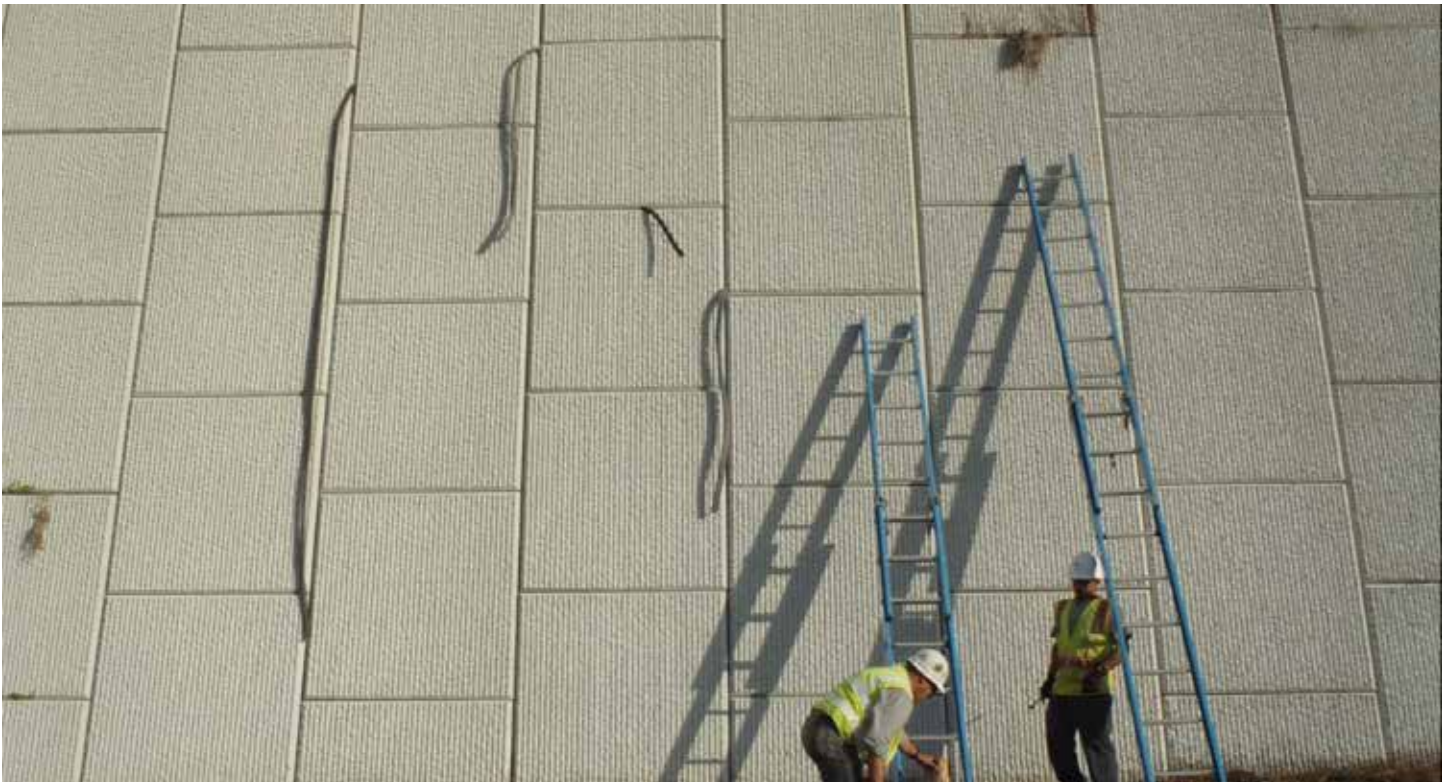
The FDS product was easily installed using a ladder and a crew of three men (Fig. 4). On a larger retrofit project, a high lift would work better where there is sufficient access for a piece of equipment.

Figure 4: Installation of the FDS product

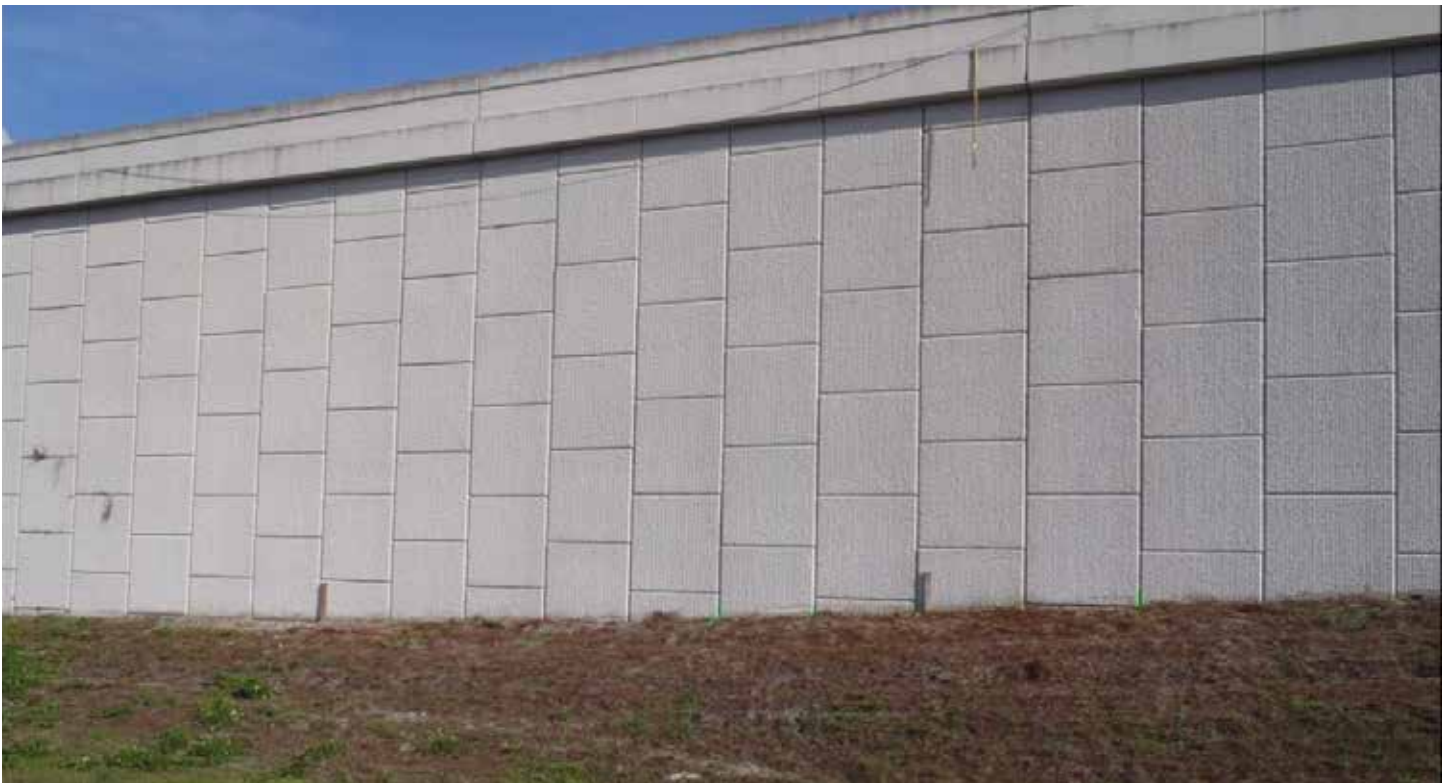
1. The test section that had the FDS product installed did not have any vegetation growing in the joints. The product performed as designed for the MSE Wall retrofit application (Fig. 5).
2. The test section that did not have the FDS product installed in the joints had some vegetation growing out of the joints.

Figure 5: Test Sections - one year later - March 2014

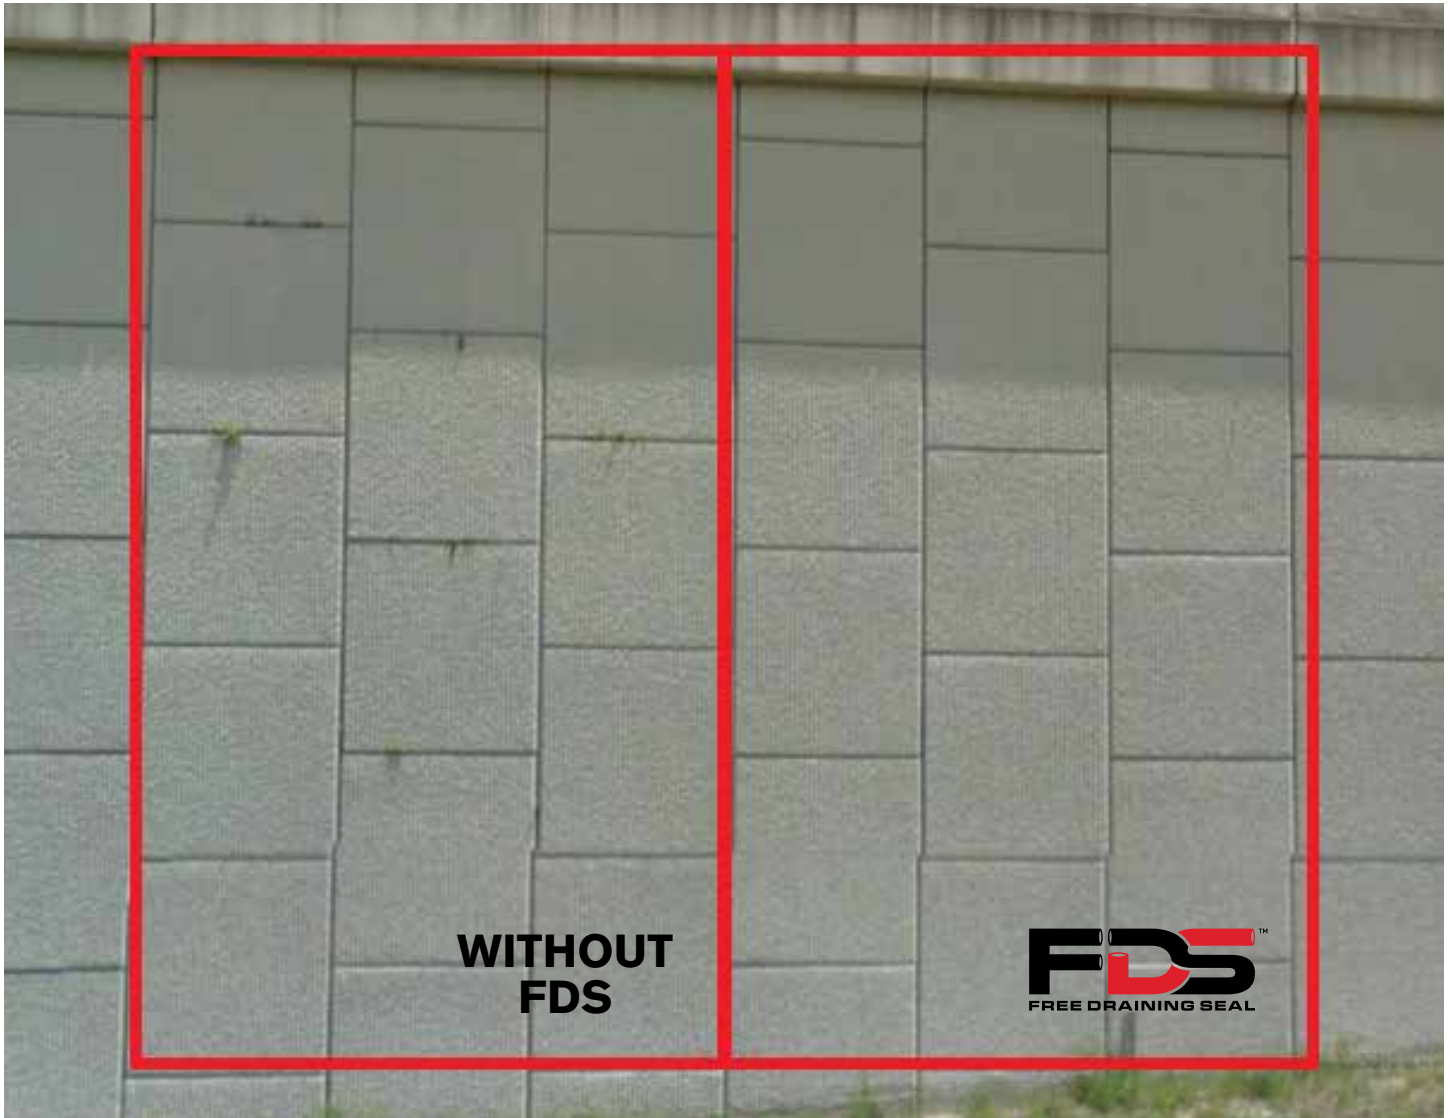
The test sections were again evaluated in November of 2017 and the MSE Walls with the FDS product installed remain vegetation free while the MSE Walls without the FDS product have vegetation growth (Fig. 6).

Figure 7: Test Wall November 2017
